## Fluid inside driveline after left ventricular assist device implantation: A rare case

Tanıl Özer<sup>1</sup>, Mustafa Mert Özgür<sup>1</sup>, Özge Altaş<sup>1</sup>, Davut Çekmecelioğlu<sup>1</sup>, Sabit Sarıkaya<sup>1</sup>, Kaan Kırallı<sup>1</sup>

Department of Cardiovascular Surgery, Kartal Koşuyolu Yüksek İhtisas Training and Research Hospital, Istanbul, Turkey

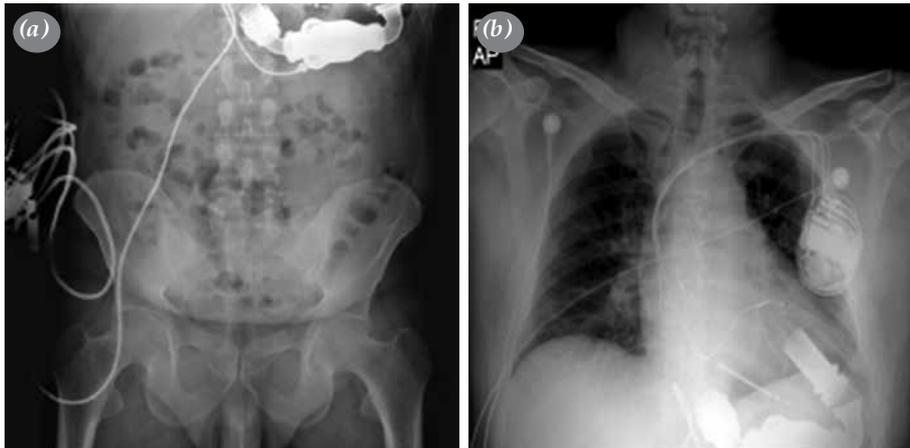
**Figure 1.** Left and right panels of X-ray showing no visible lesions of driveline and device.

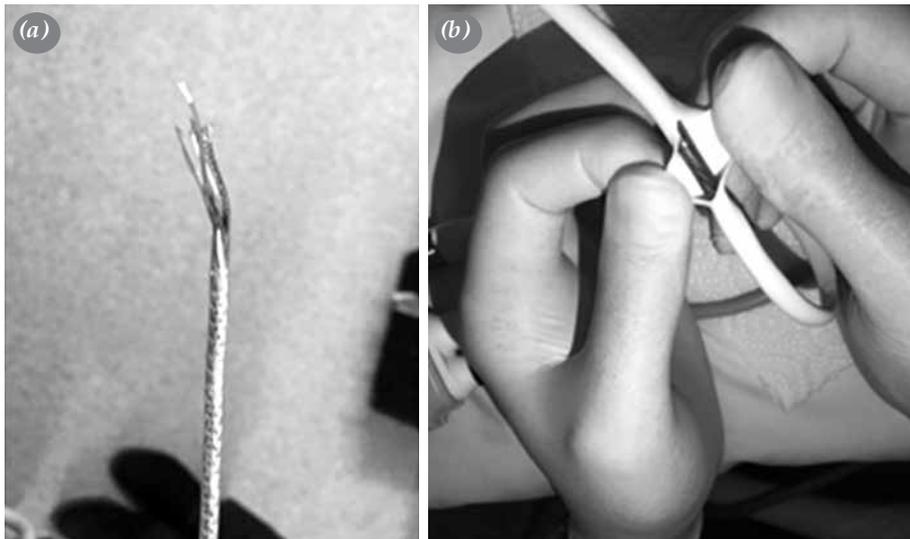
On 2017-01-16, an external driveline evaluation was performed by the manufacturer's Technical Services representatives and fluid was found inside the driveline. It was reported that no further intervention is possible and that the plan is for the patient to receive a heart transplant as soon as possible. No further information was provided. A final report will be submitted when the manufacturer's investigation is completed.

**Figure 2.** (a) Showing original view of cables after silicone cuff removed, (b) showing green-color and lubricated view of cables after technical service cut the silicone cuff, and (c) showing official report of manufacturers' technical staff.
