Outflow graft twisting of Heartmate III left ventricular-assisted device: A case report

Oğuz Konukoğlu¹, Denyan Mansuroğlu¹, Özgür Yıldırım¹, Shiraslan Bakshaliyev¹, Kenan Sever¹, Mehmet Balkanay¹

Department of Cardiovascular Surgery, Yeni Yüzyıl University, Private Gaziosmanpaşa Hospital,, İstanbul, Turkey

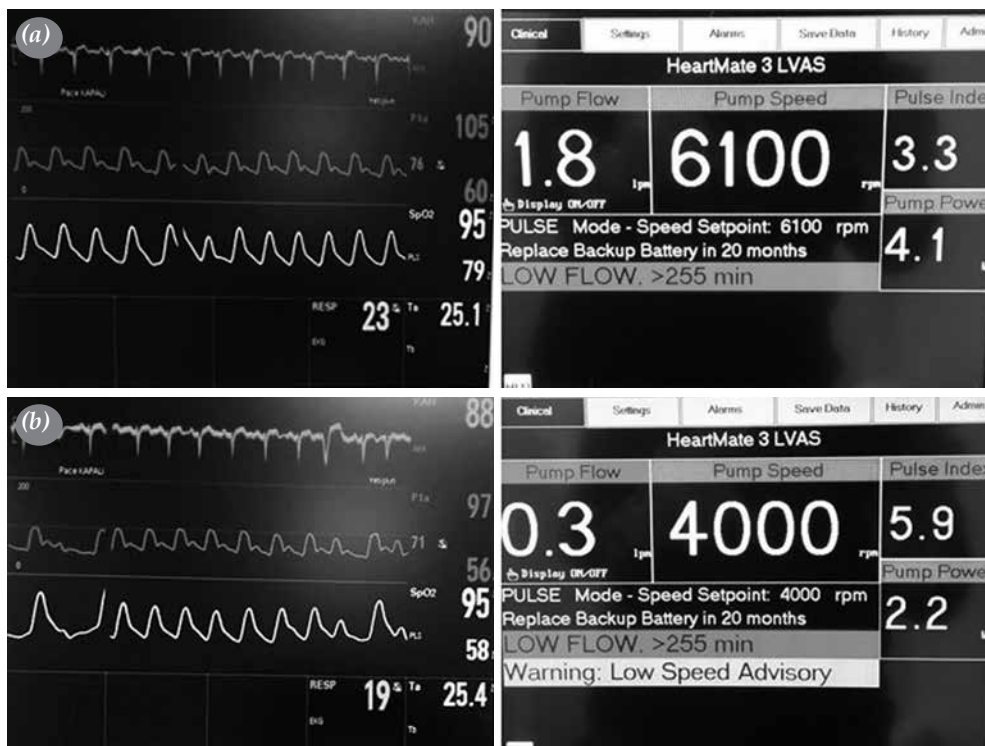
A 57-year-old man with ischemic cardiomyopathy and a history of coronary artery bypass grafting (CABG), stroke, and mild left arm disability underwent LVAD implantation as bridge to transplantation. He was on a stable course until the event (approximately 5 L/min, 5,500 rpm, 3.5 pi, 4.2 watts). At 13 months of support, he was admitted to the hospital with low flow alarm on the LVAD. The pump flow decreased to 1.9 L/min with no further evidence. There were no signs of thrombus on echocardiogram at the time of admission. Lactate dehydrogenase (LDH) levels were not elevated (174 U/L). Both increasing and decreasing the rpm levels of the LVAD, slick response of flow levels and non-changing prominent arterial pulses were remarkable (Figure 1). However, on Day 1, LDH levels

Figure 1. Arterial pulsatility was not affected, when the pump speed increased (Row A) or decreased (Row B) due to low flow of left ventricular assist device even at a high rpm.

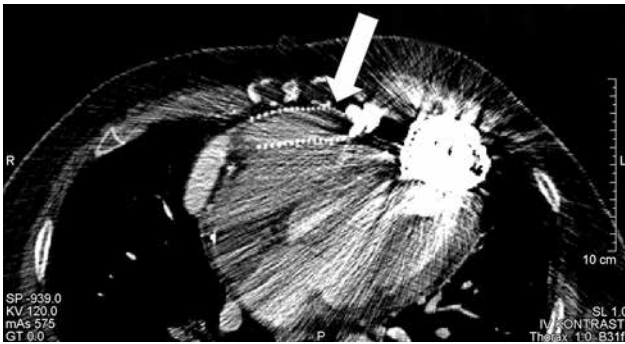
were elevated to 320 U/L. 30 mg of tissue plasminogen activator (tPA), alteplase administered as three separate 10 mg doses of one-hour infusion; however, no change was observed in terms of pump parameters. On contrast-enhanced computed tomography (CT) angiography, no signs of pre- or post-pump obstruction was present. In addition, there was a susceptible obstruction at the beginning of the outflow graft (Figure 2). The patient health status was deteriorated due to the regressing flow of LVAD to 0.9 L/min. Femoral venoarterial (V-A) extracorporeal membrane oxygenation (ECMO) support was administered for hemodynamic stabilization. The patient was taken to catheterization lab. The patient was heparinized to achieve an activated clotting time (ACT) level of 300 sec. The LVAD was stopped, permitting the retrograde flow from the pump. The contrast material was given from the level of distal anastomosis of the outflow graft. The sand-glass shaped obstruction was seen at the beginning of the outflow graft, departing the LVAD (Figure 3).

Figure 2. A computed tomography angiography showing susceptible counter clockwise twisting in the beginning of outflow graft.

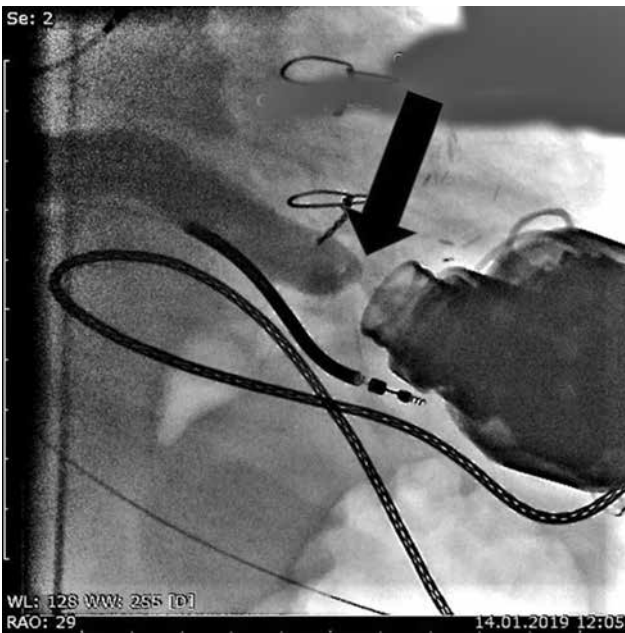
Figure 3. During conventional angiography, contrast material was given retrogradely from aortic inlet following pump stoppage.

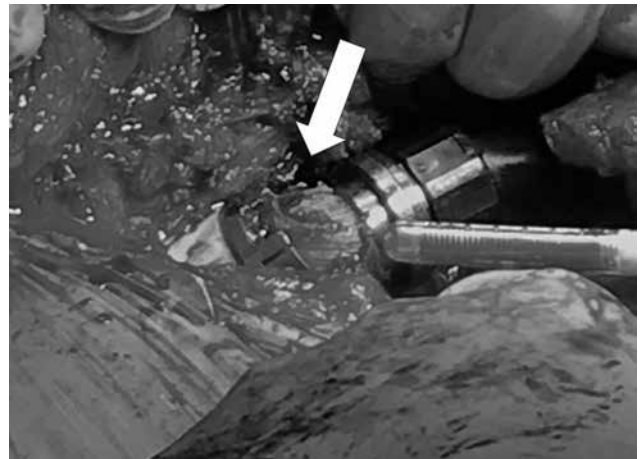
exposure, the medial intercostal cartilage was cut and the swivel joint was exposed. The outflow graft protector cuff was removed by its special removal clamp, and a counter-clockwise (approximately 120°) twisted outflow graft was revealed (Figure 4). The outflow graft was turned opposite to its twisting direction from the swivel joint. In addition, the outflow graft protector cuff was re-attached to its original position. Following the rotation, LVAD parameters returned to normal levels. The ECMO was gradually weaned off using transesophageal echocardiography and pulmonary artery pressure monitorization in the operation room. The patient was extubated next day and discharged 15 days after the operation.

Figure 4. Intraoperative swivel joint and counter clockwise twisted outflow graft.

In the previous reports, surgical intervention was applied to all patients. This approach typically include the turning of the outflow graft opposite of the twisting. Only Potapov *et al.*⁹¹ introduced a titanium cuff which was useful to stabilize the swivel joint to the outflow graft. In our case, we also countered the twisted outflow graft from the swivel joint. In addition, fixation of the protector cuff of the outflow graft to the diaphragm with sutures can be another solution.
