Treatment of outflow graft stenosis in left ventricular assist device patients: Endovascular approach

In this article, we present a successful endovascular intervention in two cases with stenosis located near the aortic anastomosis of the outflow graft.

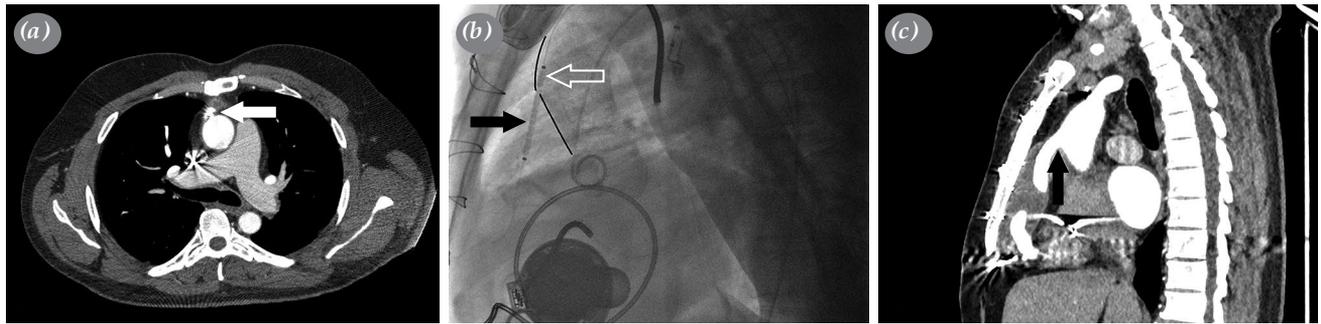
Figure 1. (a) Before stent implantation. White thick arrow indicates outflow graft thrombosis and severe stenosis on aortic anastomosis level. (b) Stent implantation. Angiographic view of the unopened stent's extension to aorta during implantation. 5 to 10 mm of stent was left in aorta (arrow). Thick arrow indicates main stent body left in outflow graft. (c) After stent implantation. Thick arrow indicates opened outflow graft-aorta anastomosis.

Under local anesthesia, after the administration of 5,000 units of unfractionated heparin, the femoral arteries were accessed bilaterally with sheaths via the Seldinger technique and, from the right side, a 5Fr pigtail catheter (Terumo Corporation, Leuven, Belgium) was placed to the ascending aorta. Angiography was performed. The LVAD pump speed was reduced gradually. From the left groin, a 0.035-inch guidewire (Terumo Corporation, Leuven, Belgium) and a 5Fr vertebral catheter (Terumo Corporation, Leuven, Belgium) were used to navigate into the outflow graft across the stenosis. The pump was stopped temporarily and a 10×38-mm balloon expandable covered stent (Atrium Medical Corp., NJ, USA) was subsequently placed across the stenosis and post-dilated with a

12-mm balloon. The LVAD was set to its original settings. Approximately 5 to 10 mm of the stent was left in the aorta and did not cause any problems in hemodynamics (Figure 1b). The pump parameters returned to the normal values. No neurological or occlusive vascular injury was detected in the early post-procedural course.

Follow-up CTA confirmed the patency and proper positioning of the stent (Figure 1c). Outpatient visits of the patient were uneventful and, six months later, the patient was bridged to heart transplant and he is still alive.

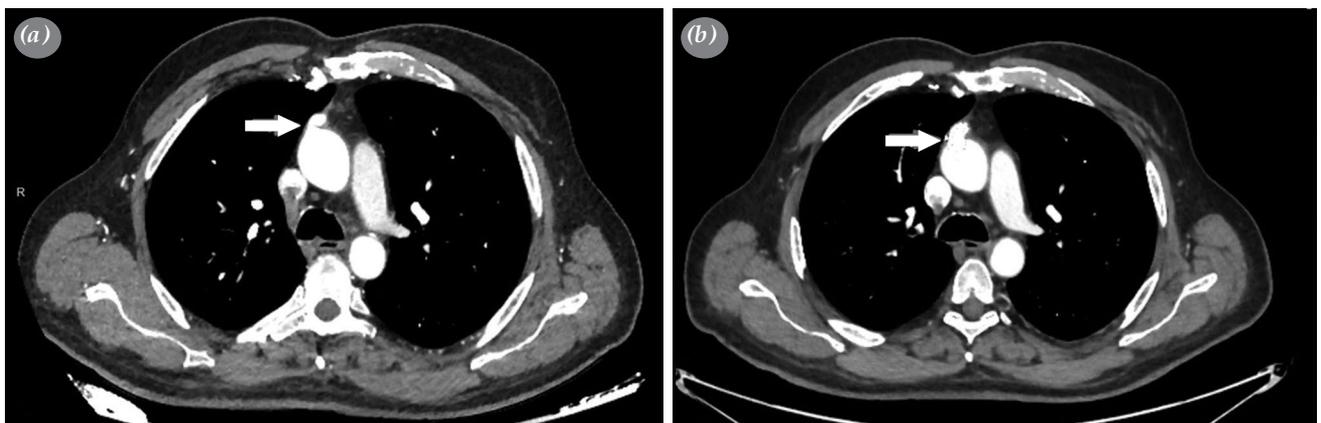
Figure 2. (a) Before stent implantation. Arrow indicates outflow graft severe stenosis on aortic anastomosis level. (b) After stent implantation. Arrow indicates opened outflow graft-aorta anastomosis.

was 2.8 Watt, and LDH was 283 U/L. No infectious process was seen. The TTE examination revealed no signs of intracardiac thrombus and aortic valve opening was seen in every heartbeat. The CTA did not reveal inflow cannula obstruction, but yielded severe stenosis in the outflow graft at the aortic anastomosis level as in the previous patient (Figure 2a). The same stent implantation procedure (10×38-mm balloon expandable covered stent, Atrium Medical Corp., NJ, USA) was performed. The pump settings had reached the normal level (3.8 L/min, 4.2 Watt on 2,700 rpm). On follow-up CTA, there was no residual stenosis (Figure 2b). Six months later, the patient remained free of symptoms and without evidence of device dysfunction or neurological event.
